CWA COMPLIANCE EVALUATION INSPECTION REPORT
U.S. ENVIRONMENTAL PROTECTION AGENCY, REGION 5

Compliance Evaluation Inspection

Skyline Blue Acres

April 20, 2017

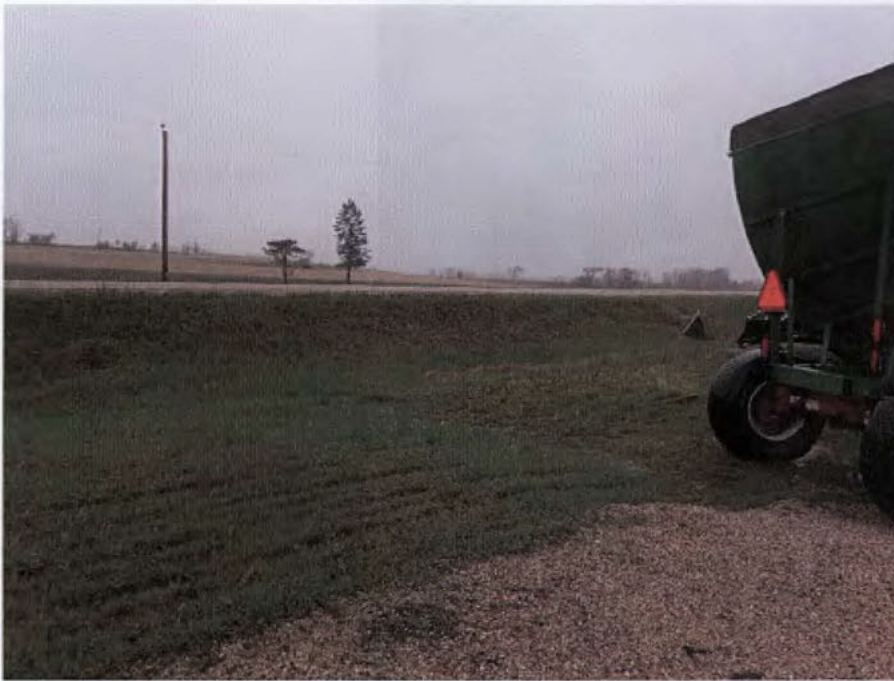
1: P4200001

Description: Buffer of vegetation along the roadside ditch. Precipitation flowing from facility to roadside ditch did not appear to contain any pollutants from the facility.

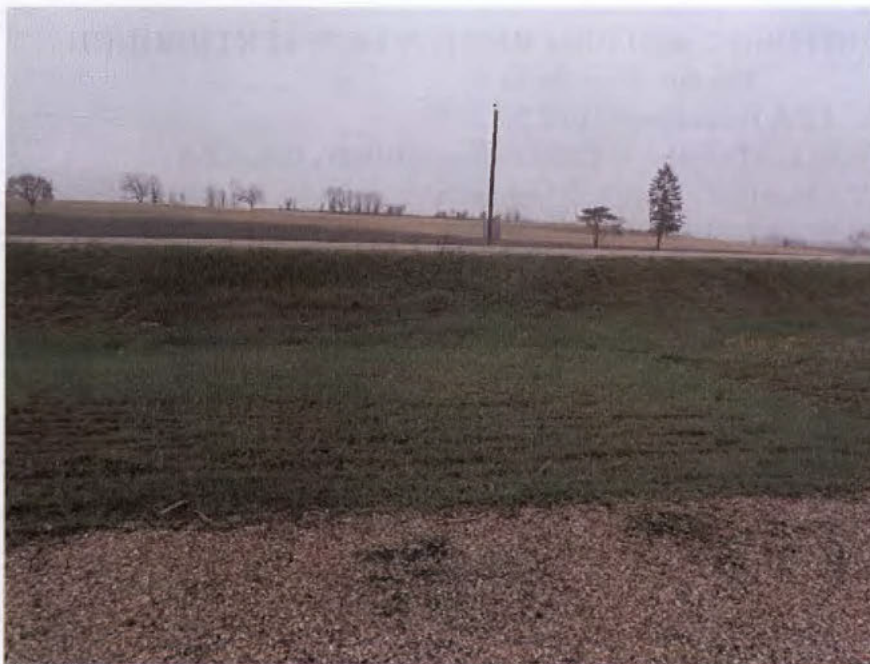
2: P4200002

Description: Buffer of vegetation along the roadside ditch. Liquid flowing into the ditch was clear.

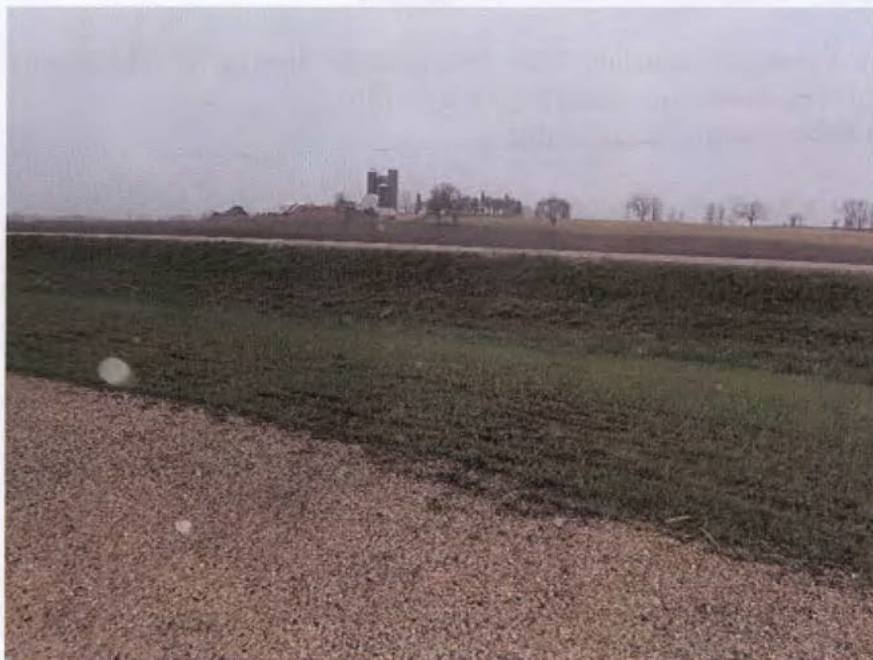
3: P4200003

Description: Buffer of vegetation along the road ditch.

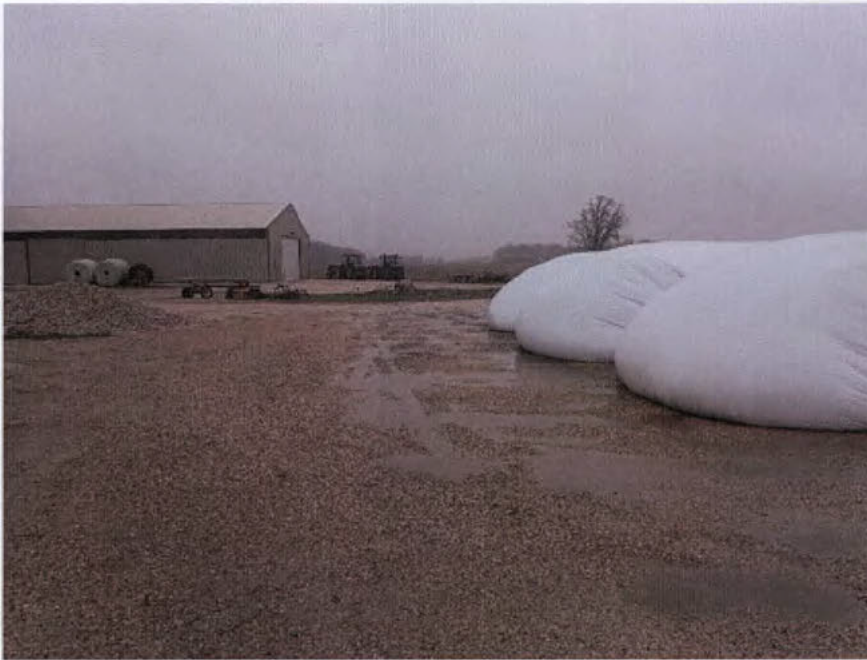
4: P4200004

Description: Silage bags are tightly sealed. Stormwater flowing from this area was clear.

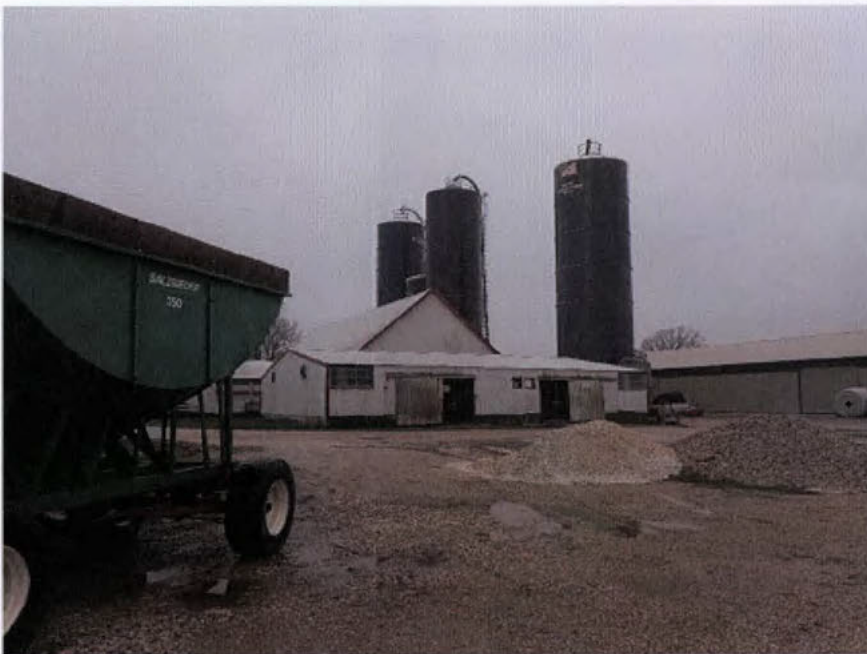
5: P4200005

Description: Piles of stone and gravel on facility driveway.

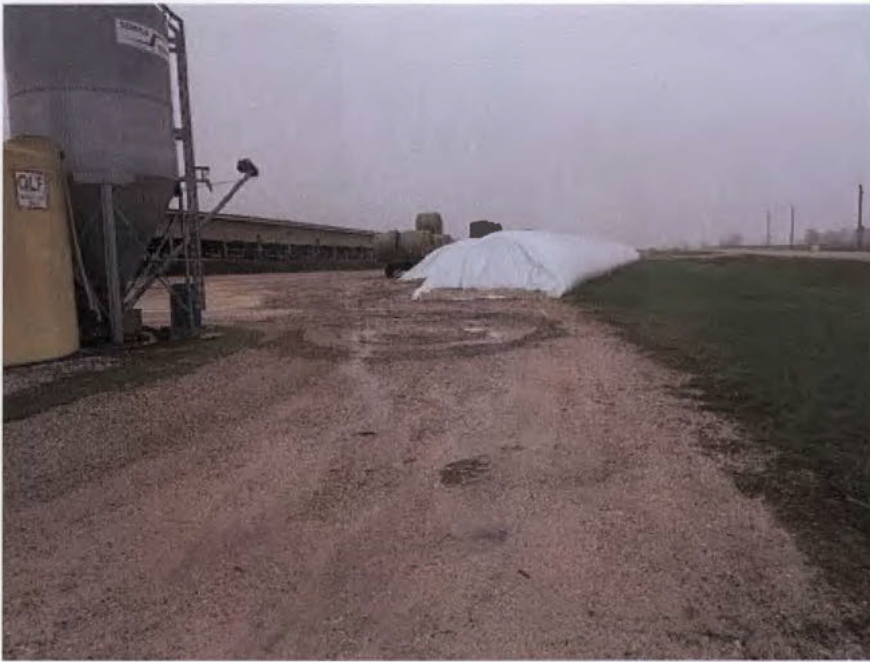
6: P4200006

Description: Silage bag south of Barn #4 was sealed on the west side. Stormwater runoff from driveway was clear.

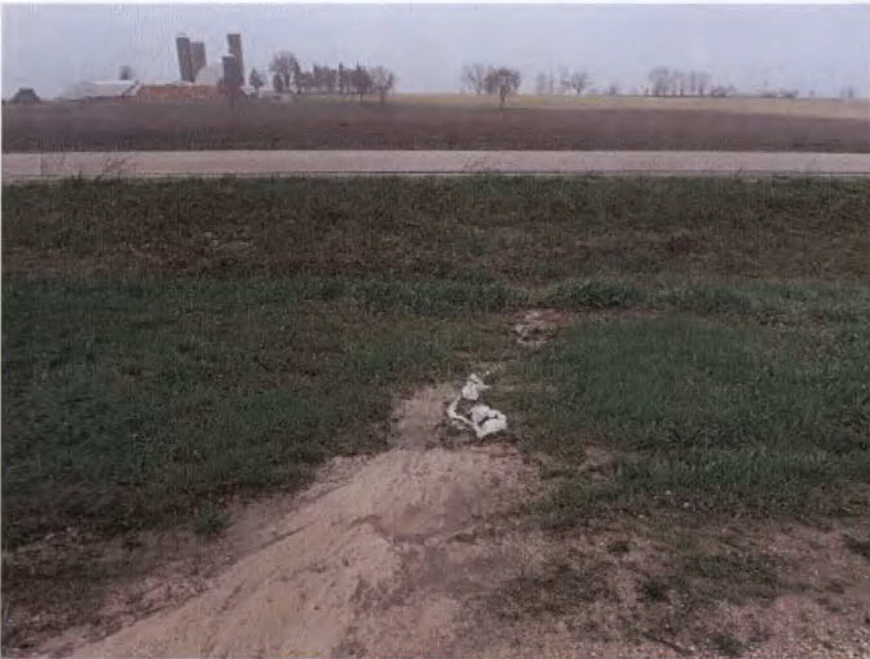
7: P4200007

Description: Flow from the driveway and some ancillary areas would flow to the roadside ditch to the south.

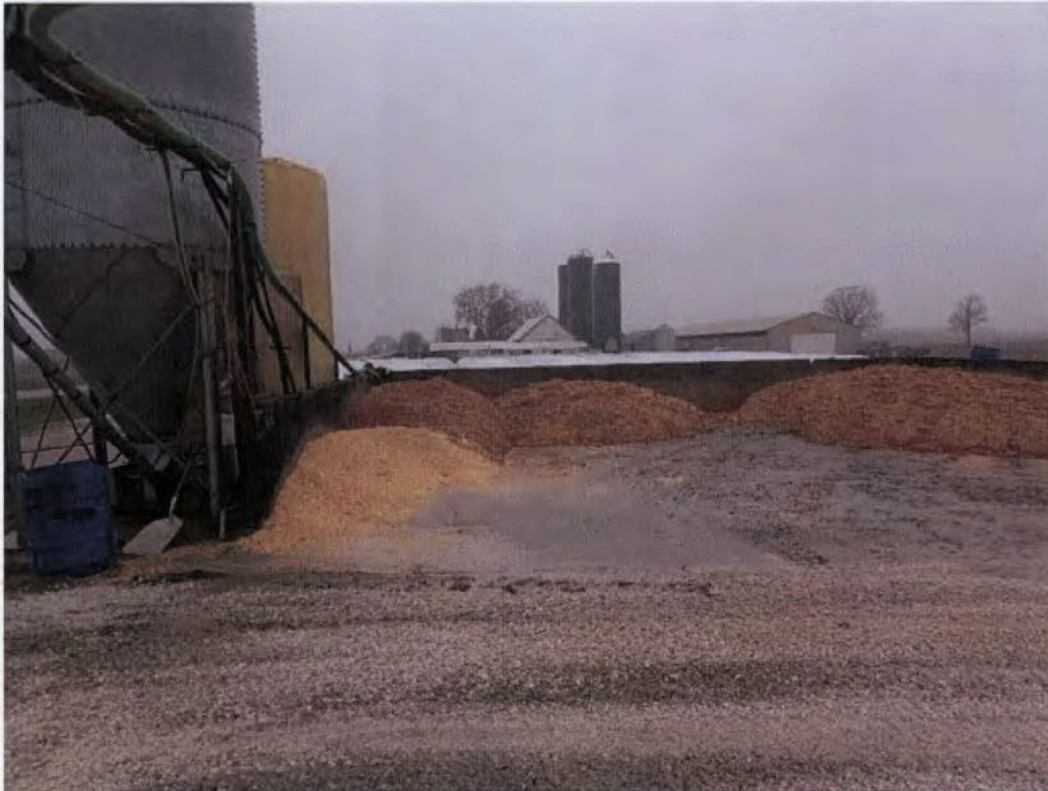
8: P4200008

EPA noted that there were no runoff controls from the Commodities Bay. Facility owner stated that a cover for the bay was to be delivered in May 2017.

In the area west of Barn #4 there was a commodity bay for high moisture corn and wet distillers grains. This bay was not covered and runoff of feed and process wastewater could flow out of the bay. The flow of the process wastewater would be to the north around the north wall of the commodity bay and then along the facility driveway to the northwest to a crop field. EPA did not observe any process wastewater flowing in this way on the day of the inspection. The facility owner stated that he had purchased a cover for the commodity bay and it was supposed to be delivered in May 2017.

Description: Commodity Bay was open to precipitation although a cover was ordered and would be delivered in May 2017. Process wastewater from the corn and wet distillers grains would flow out of the bay and then to the northwest across the facility driveway and to a crop field north of the Silage Bag area.

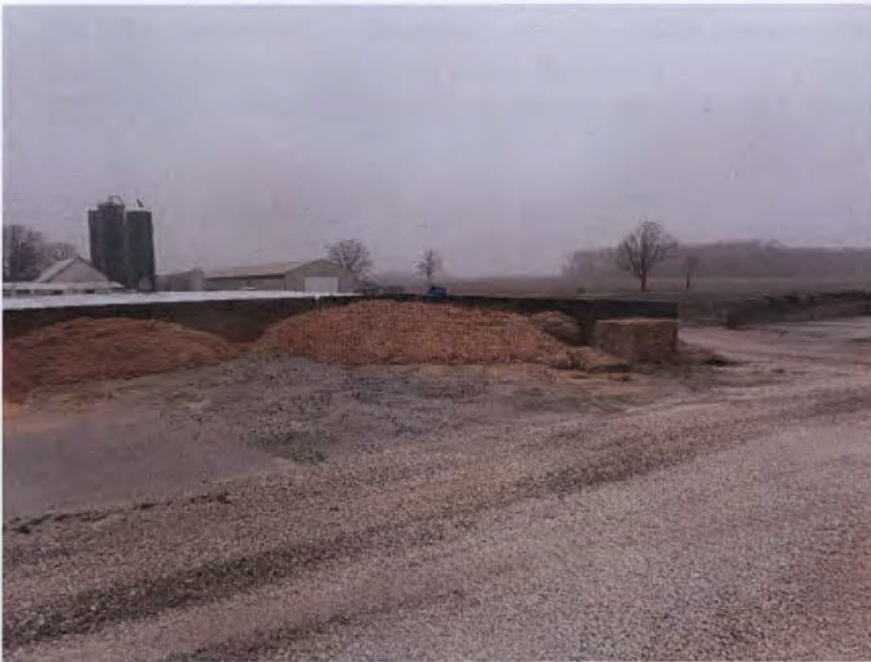
9: P4200009

Description: The flow of process wastewater off the Commodity Bay is to the northwest.

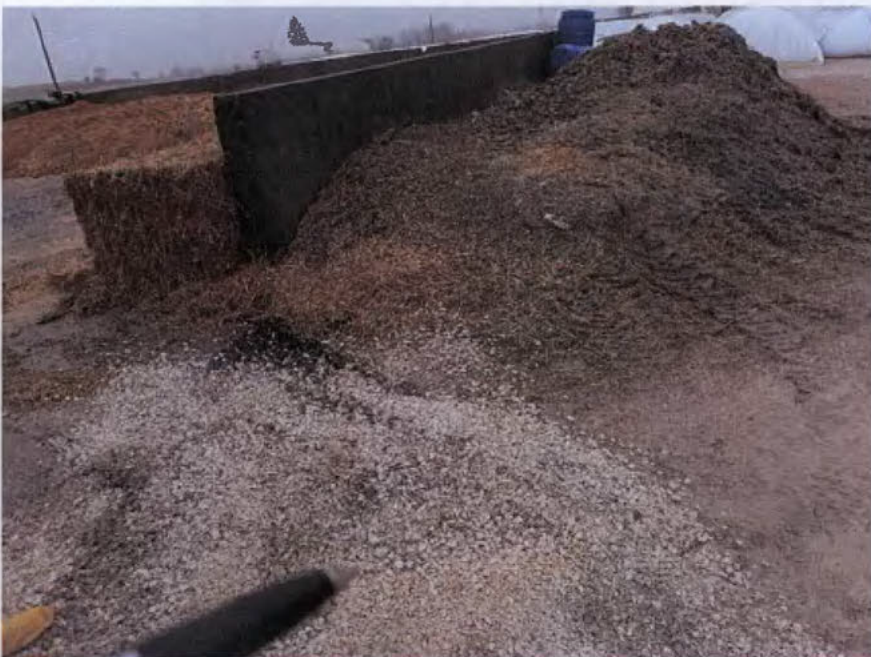
10: P4200010

Description: Flow of process wastewater off the Commodity Bay would be around the north wall and then to the northwest across the facility driveway.

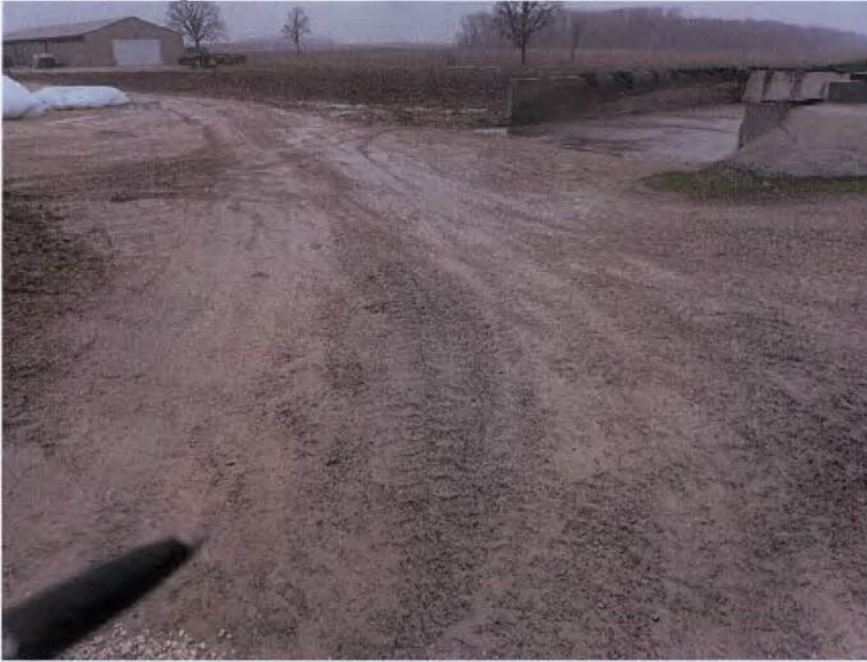
11: P4200011

Description: Flow of process wastewater off the Commodity Bay would be to the northwest and to a crop field.

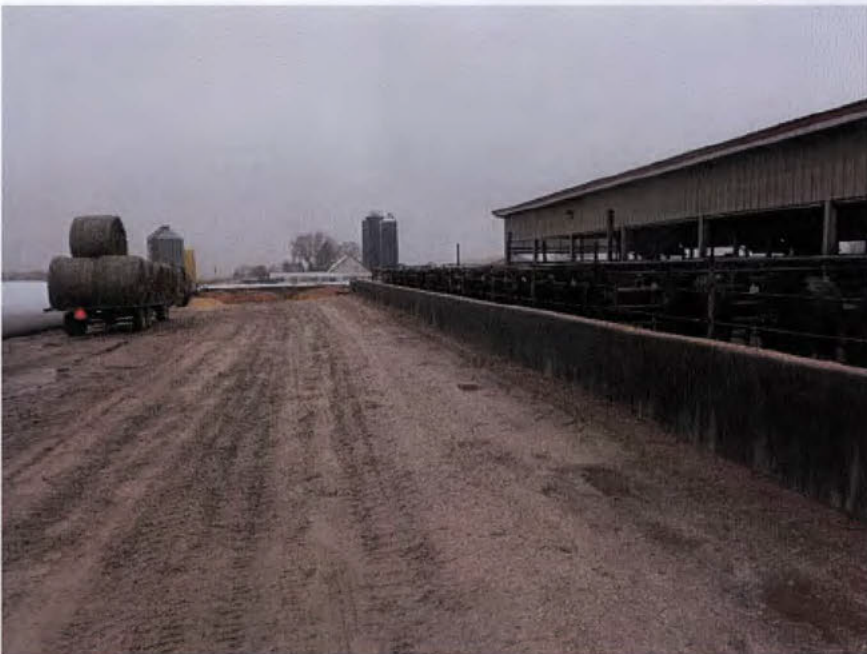
12: P4200012

Description: A high wall along the feed alley of the barns prevents feed from being pushed out.

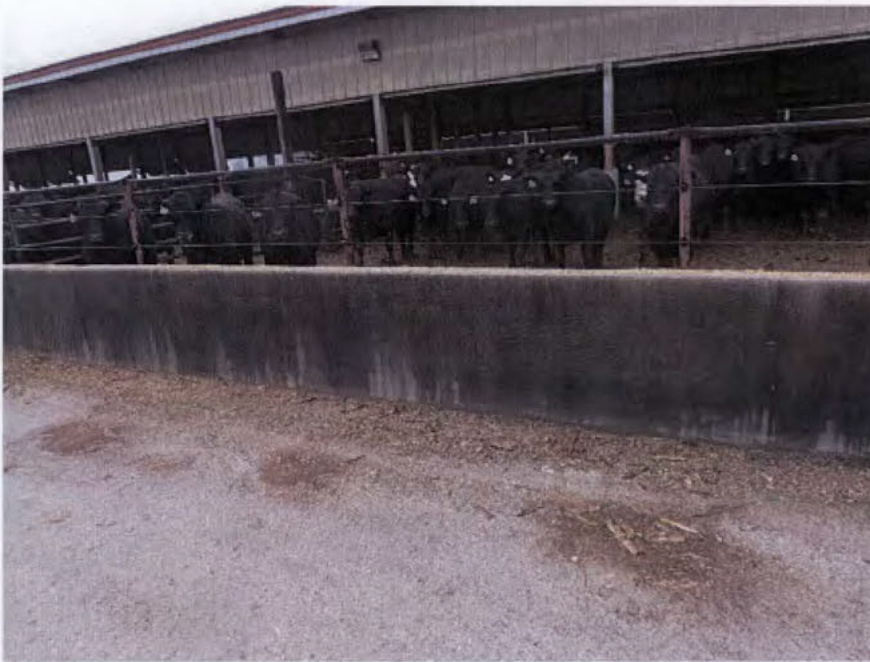
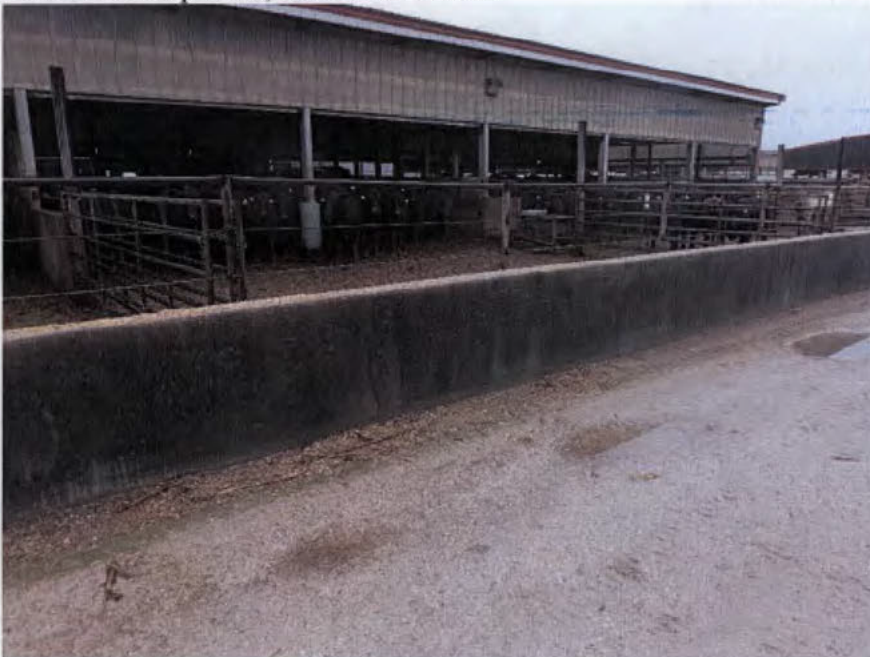
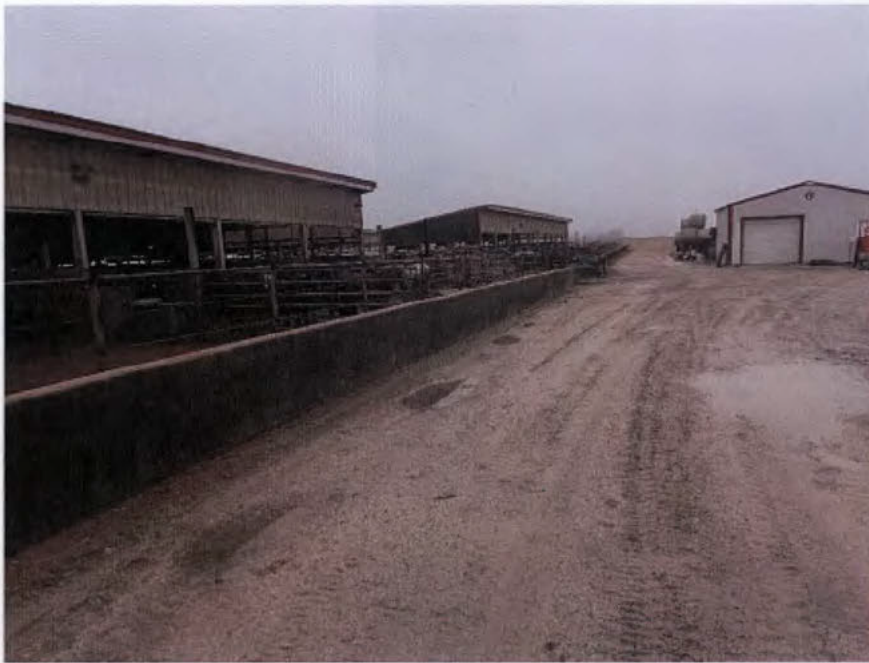
Description: Very little feed was on top of the feed alley wall and on the ground outside the pen.

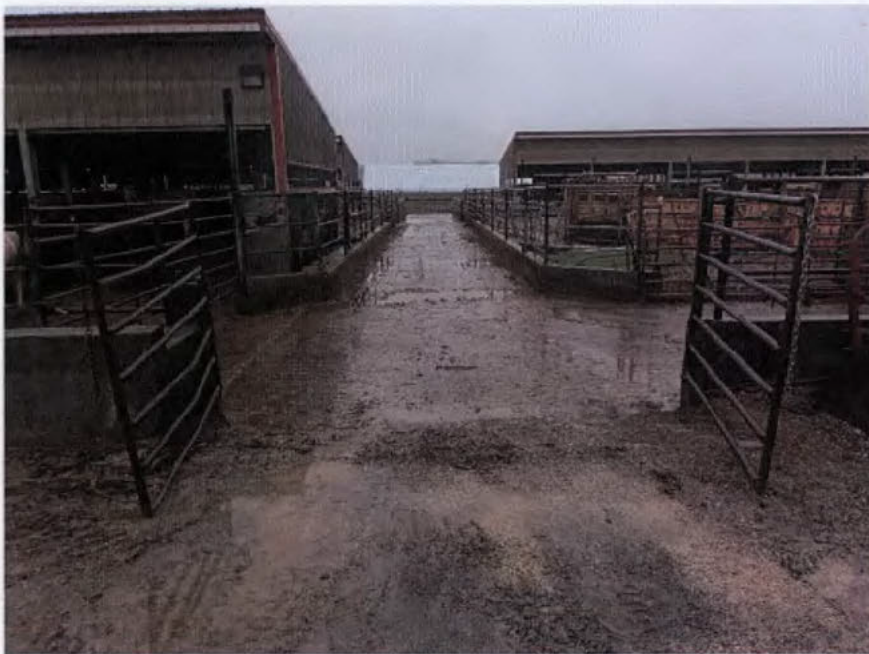
16: P4200016

Description: Scrape Alley between the barns. Manure is pushed to the Scrape Alley and then to the Manure Pond. There is a safety bar at the end of the alley before the pond.

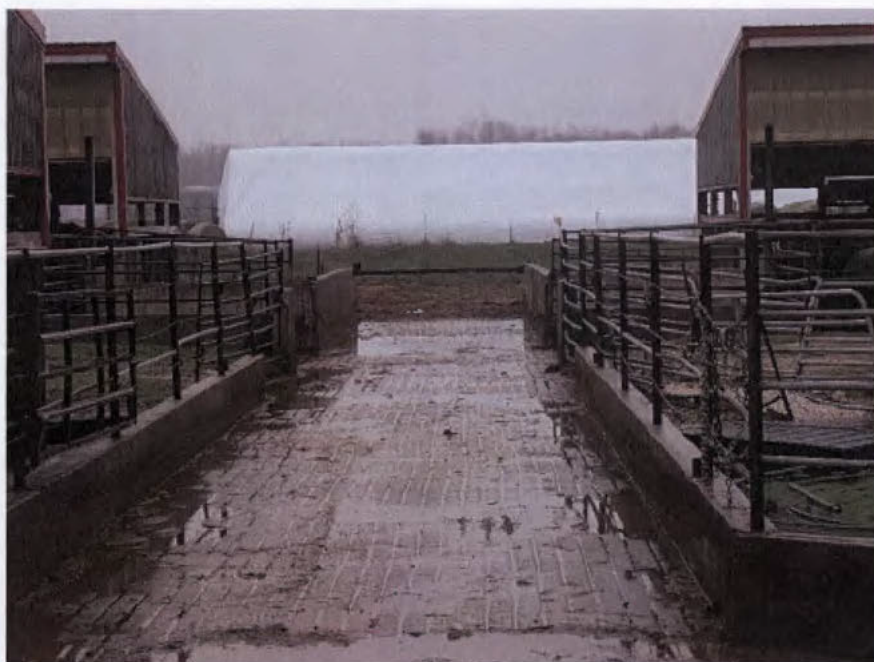
17: P4200017

Description: Scrape Alley with safety bar.

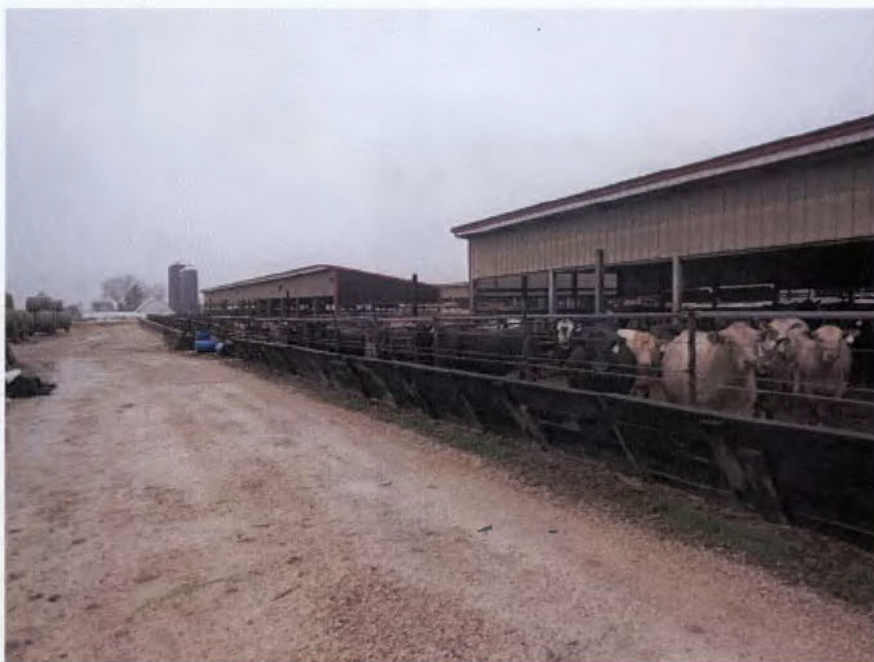
18: P4200018

Description: South side of Barn #1 in foreground and Barn #4 in background. Very little feed on the ground in front of the feed lanes.

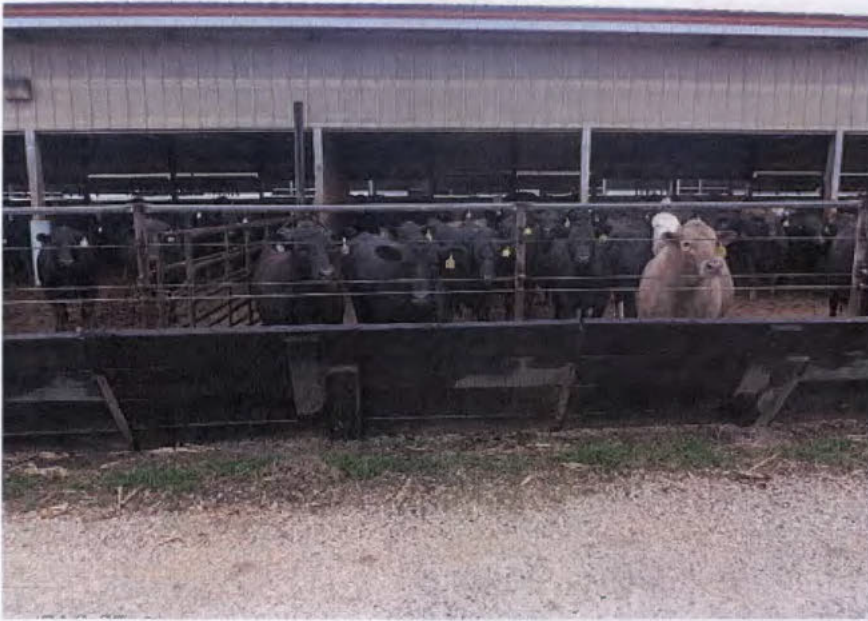
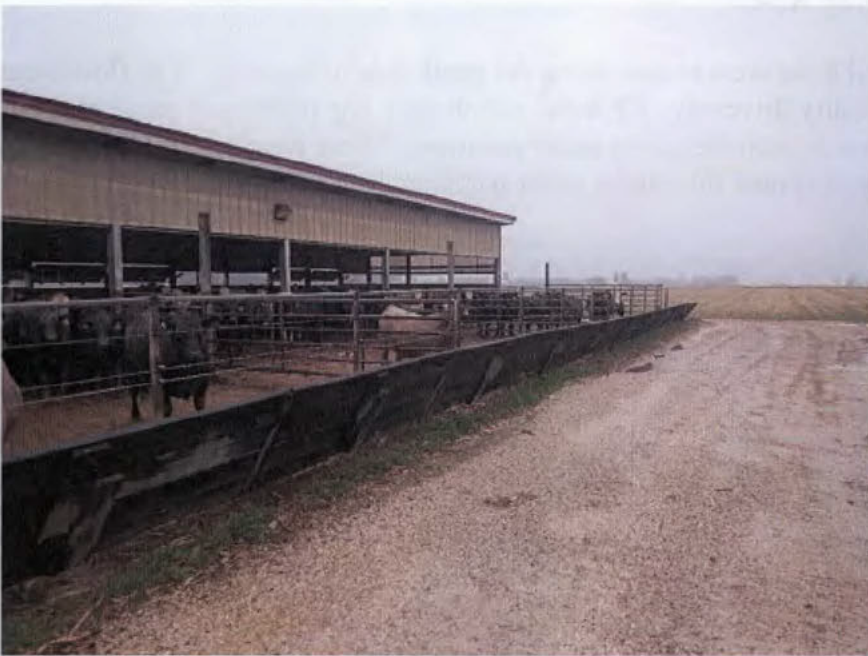
Description: High wall prevents feed from leaving the feed lane.

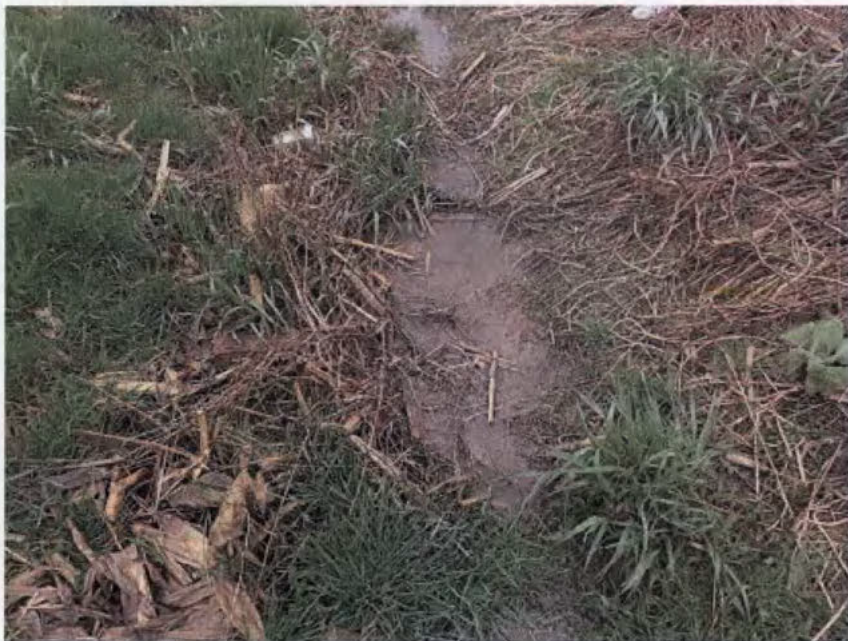
21: P4200021

Description: Stormwater ditch on east side of facility flows to the south to the roadside ditch. The water in the ditch was clear and there was no evidence of buildup of pollutants in the ditch.

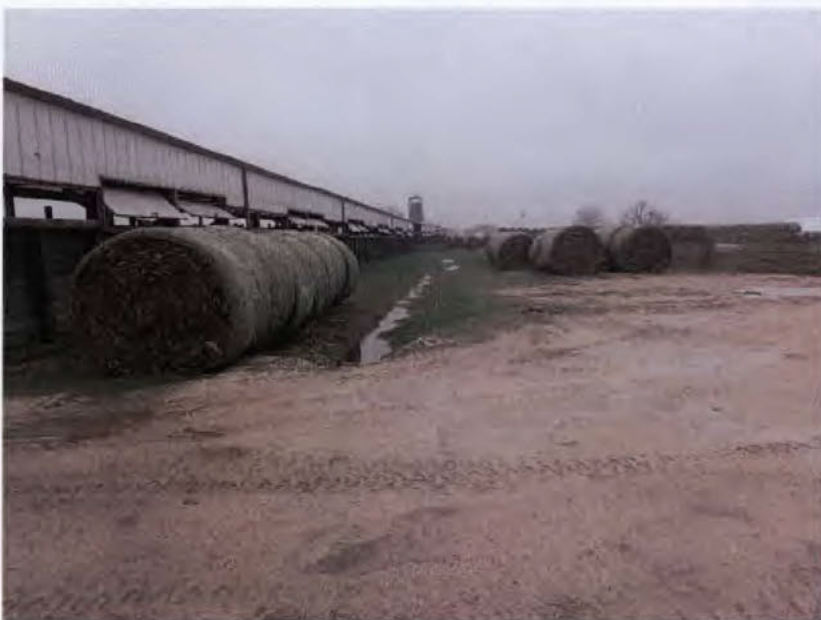
22: P4200022

Description: Stormwater pathway north of Barn #2 flows to the east and to a culvert under the facility driveway and then to the ditch on the east side of the facility.

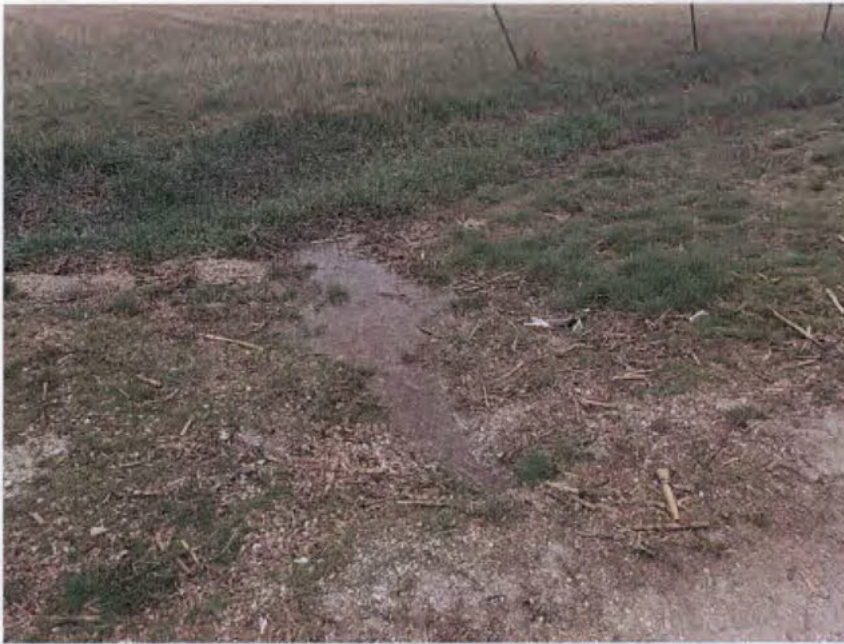
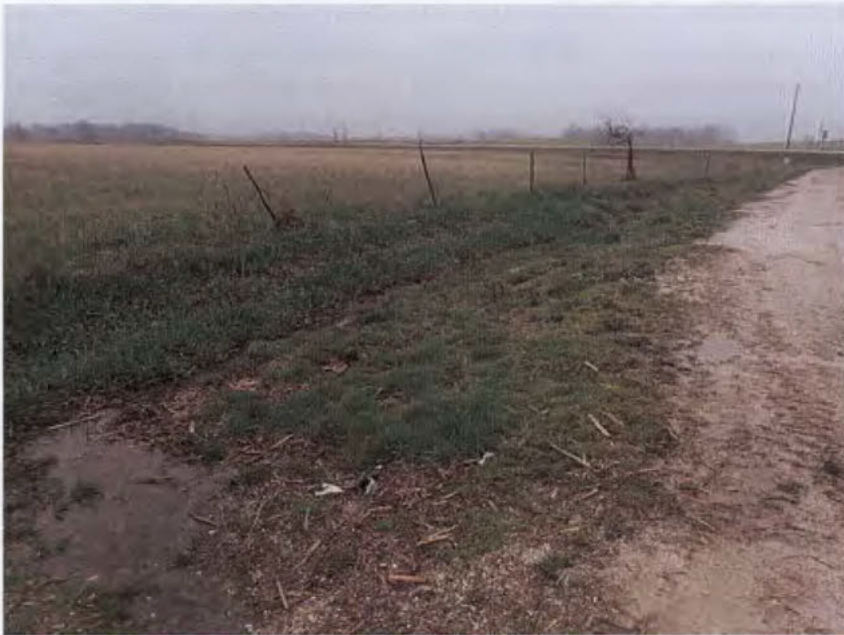
Description: Outlet of culvert under facility driveway from stormwater pathway north of Barn #2. Water in pathway was clear.

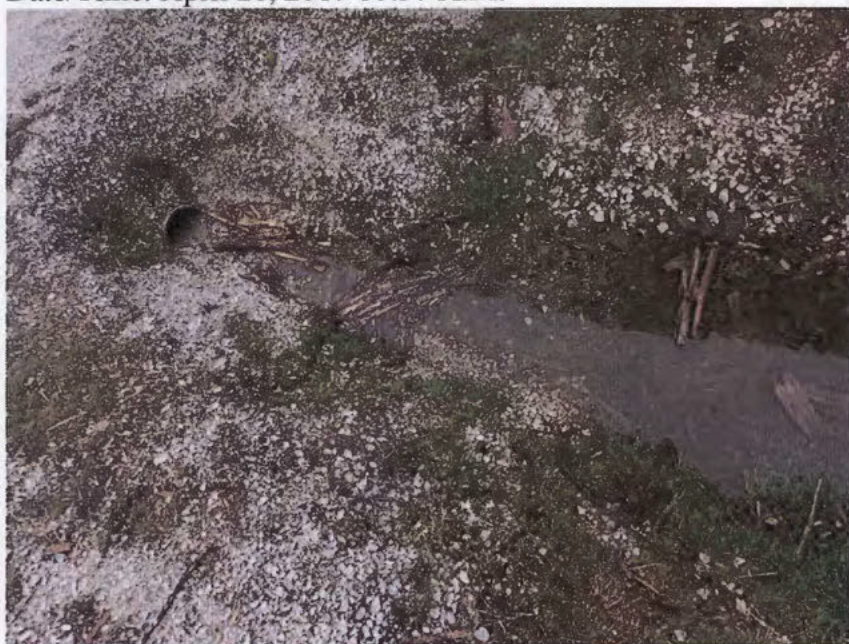
25: P4200025

Description: Inlet of culvert under facility driveway from stormwater pathway north of Barn #2. Water in pathway was clear.

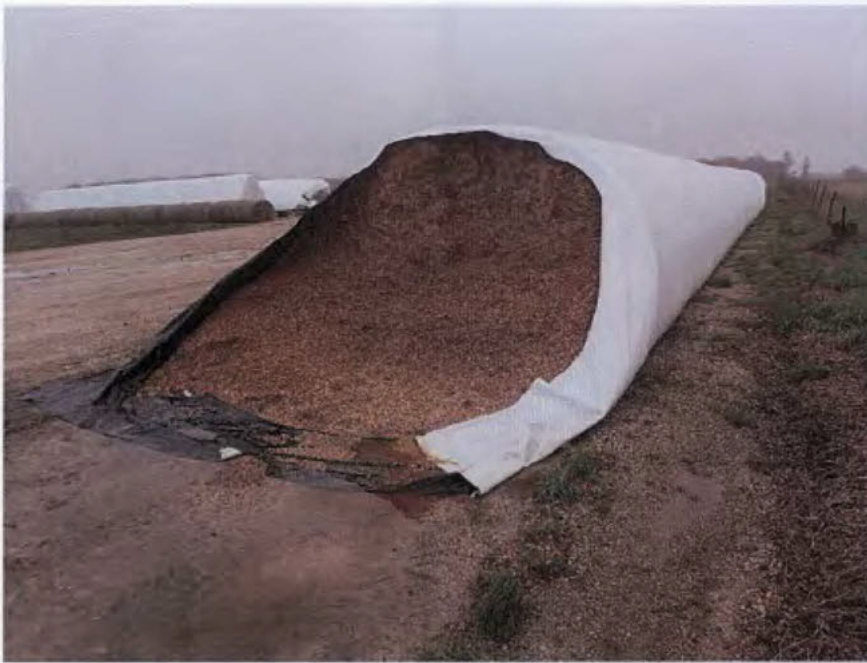
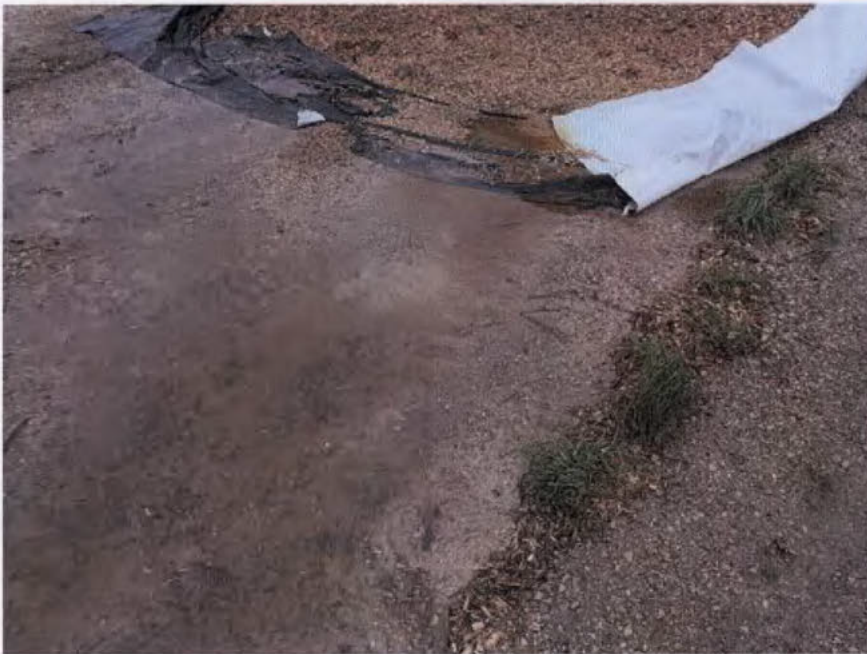
EPA then walked to the north and observed another bag of silage that was open on the south side. The tarp had been cut back and the silage was open to precipitation. A small amount of leachate was observed near the opening of the bag. The bag was located very near the ditch on the east side of the facility and EPA advised the facility owner that there was a potential for this leachate to reach the ditch on the east side of the facility if the flow from precipitation was great enough. This bag of silage was also open on the north end. EPA did not observe a discharge of feed or process wastewater to the ditch on the east side of the facility on the day of the inspection.

Description: Open silage bag on east side of facility. Small amount of leachate and track in/track out at the opening.

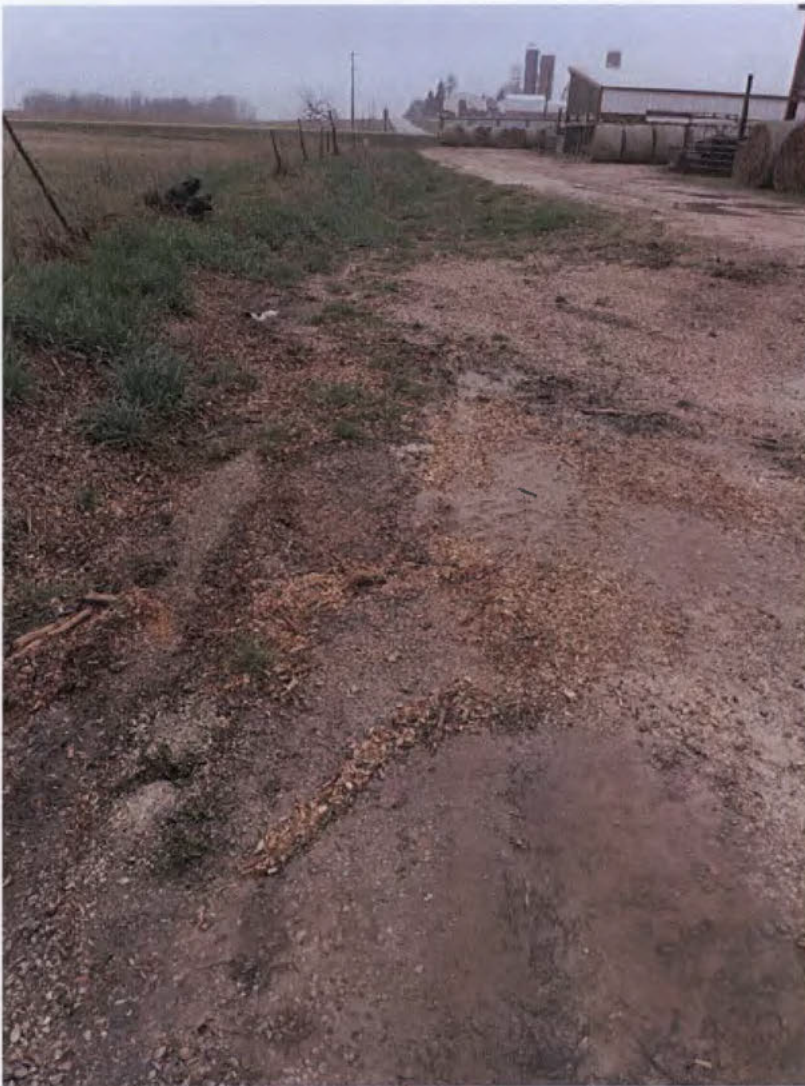
28: P4200028

Description: Open silage bag on east side of facility had a small amount of leachate and track in/track out at the opening. EPA did not observe the leachate or the feed flow over the dirt berm and into the ditch on the east side of the facility.

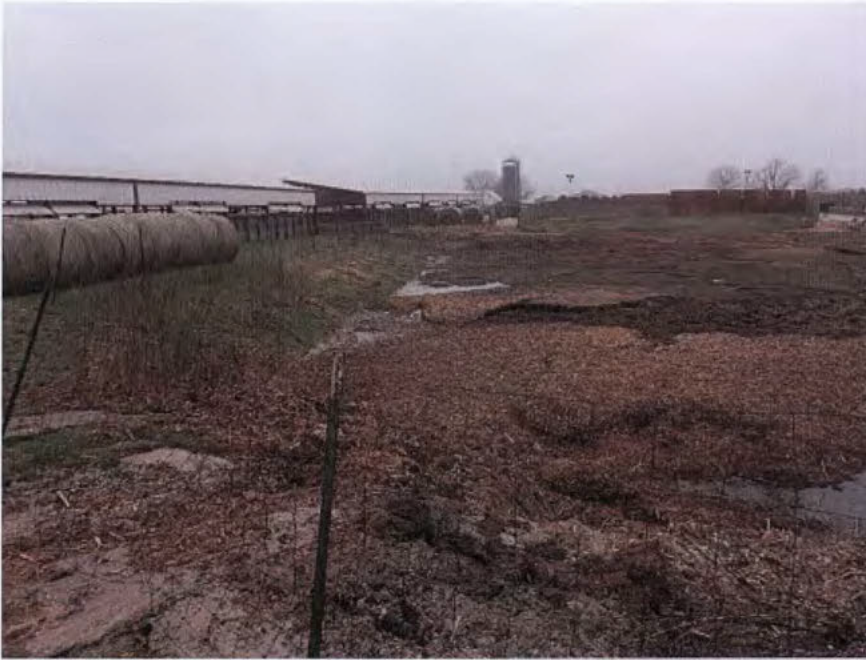
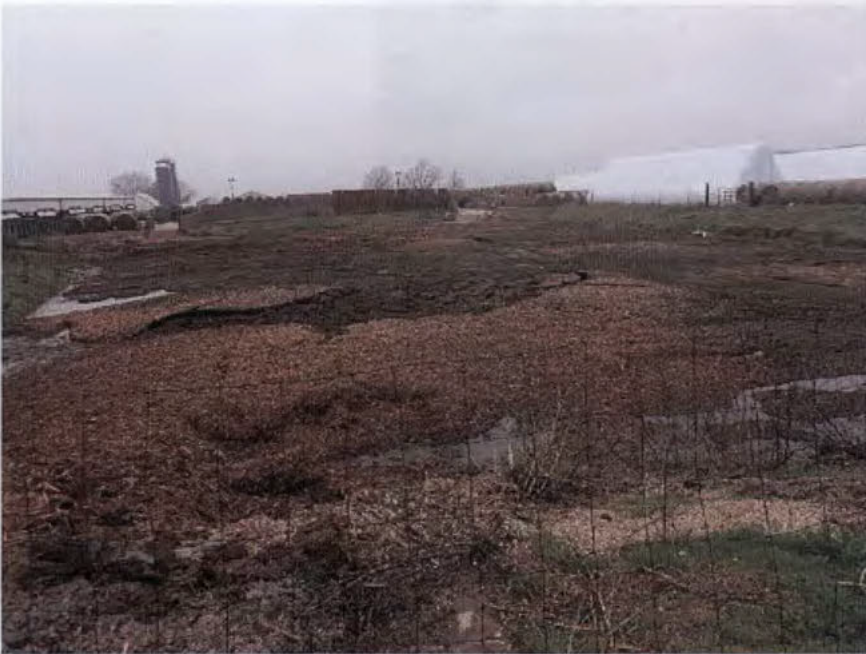
EPA then walked to the west and observed the Manure Pond. There was a heavy crust – 3 feet, according to the facility owner – on top of the manure in the pond. A staff gauge in the berm on the south side of the pond showed that there was approximately 3.5' before reaching the margin of safety mark. EPA estimated that there was approximately 4.5' of freeboard in the pond. The berms of the pond were well maintained and EPA did not observe any woody growth or rodent holes.

Description: Manure Pond has a heavy crust on it.

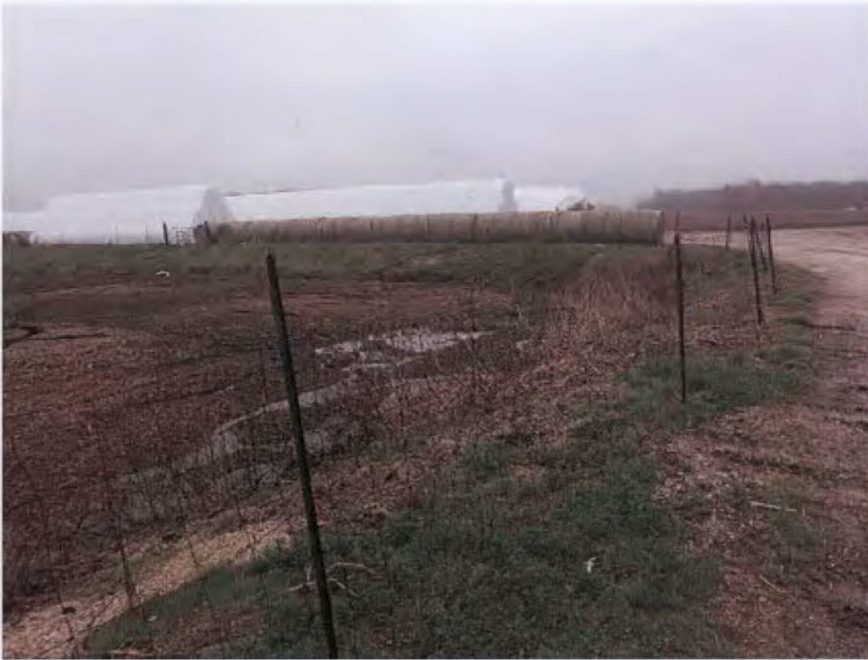
31: P4200031

Description: Manure Pond berms are well maintained.

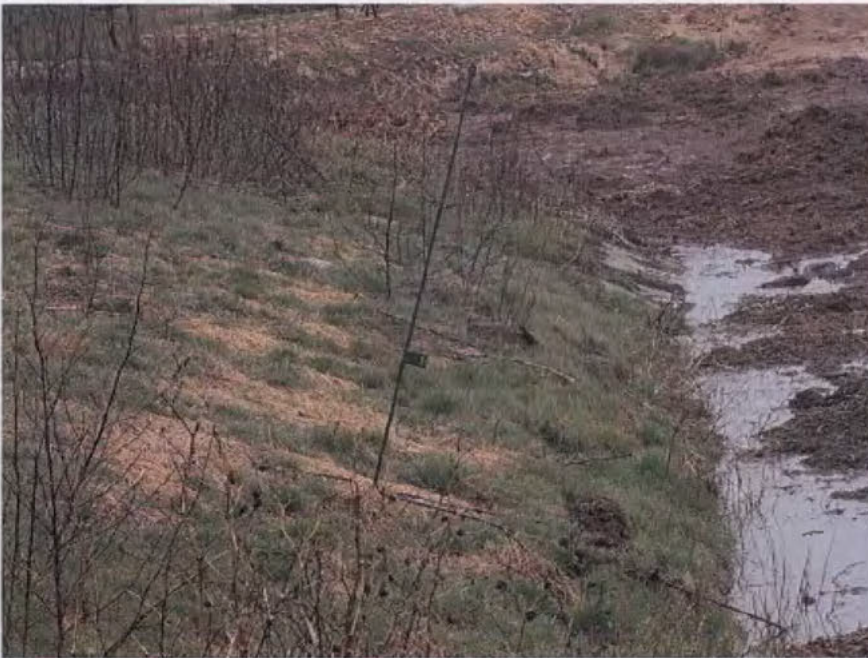
32: P4200032

Description: Staff gauge in the Manure Pond. EPA estimated that there was approximately four and a half feet of freeboard in the pond.

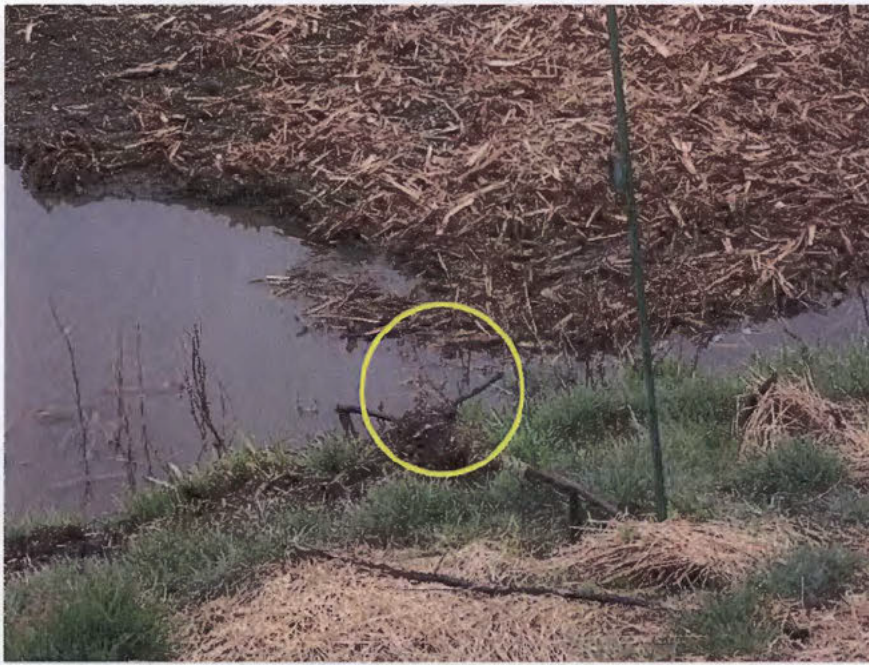
33: P4200033

Description: Bars on staff gauge (one is visible and circled in yellow) are placed to represent two feet of vertical depth in the pond.

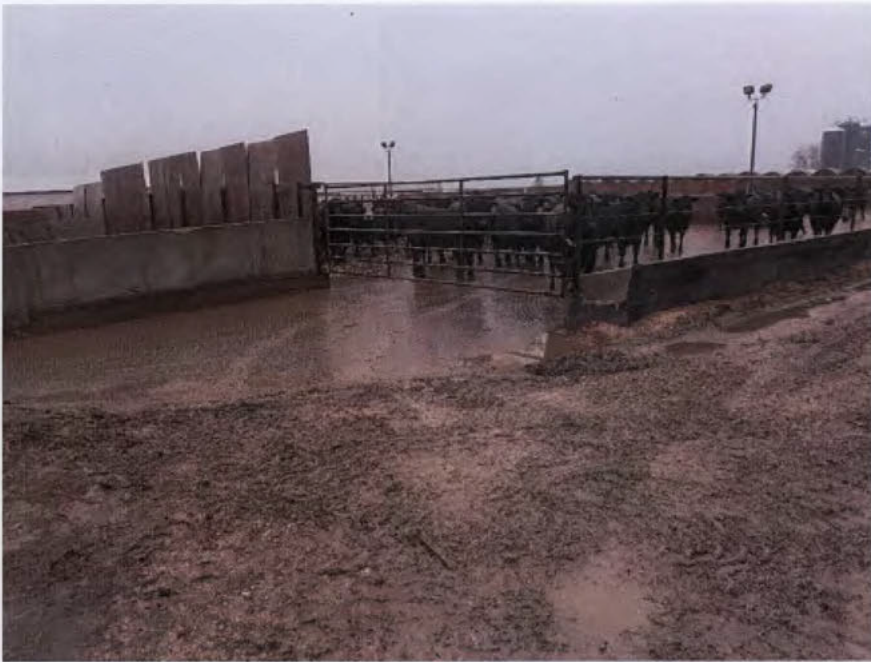
34: P4200034

Description: The feed trough for the open lots is on the north side. Manure from the open lots is scraped directly to the Manure Pond.

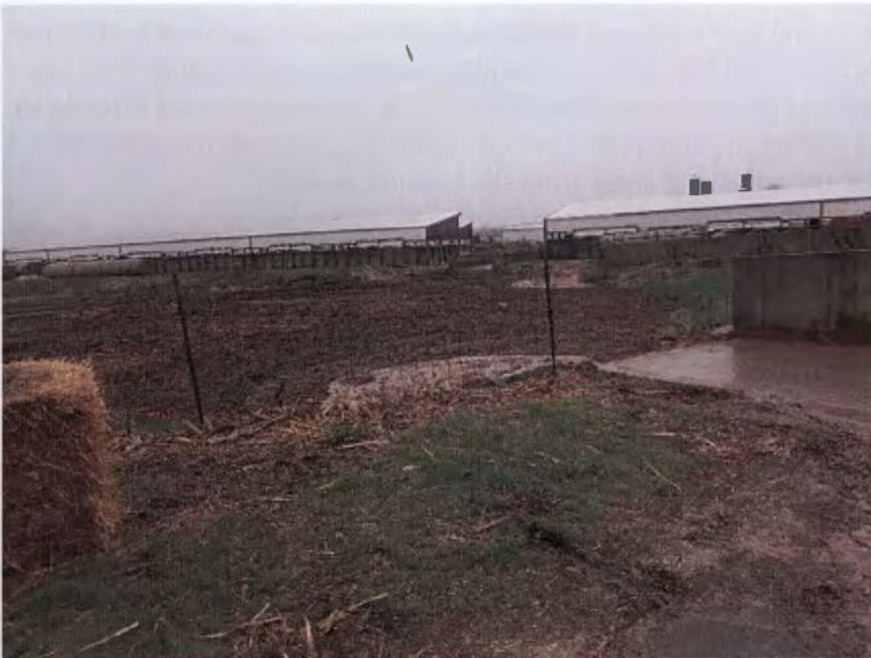
35: P4200035

Description: Manure from the open lots is scraped directly into the Manure Pond.

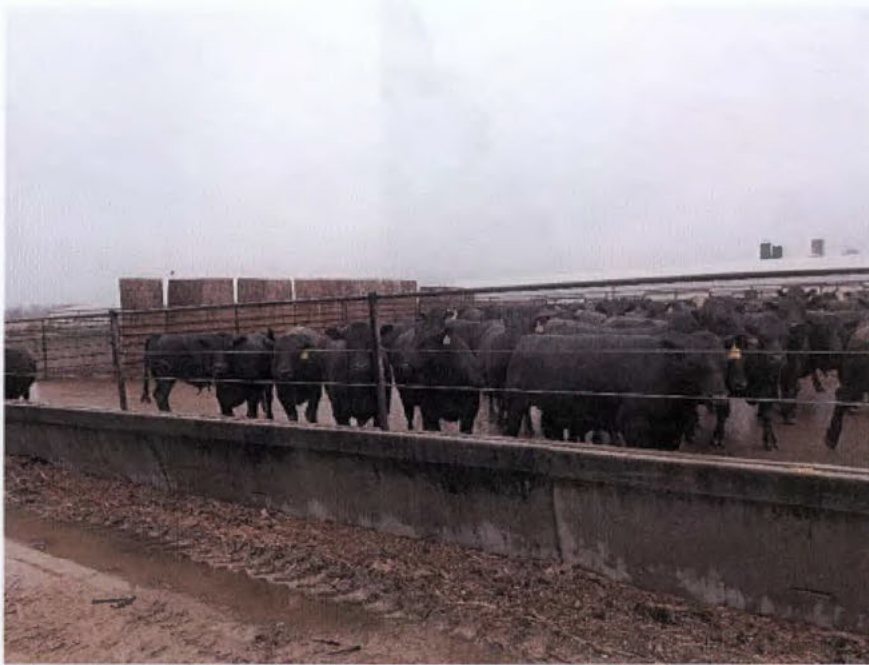
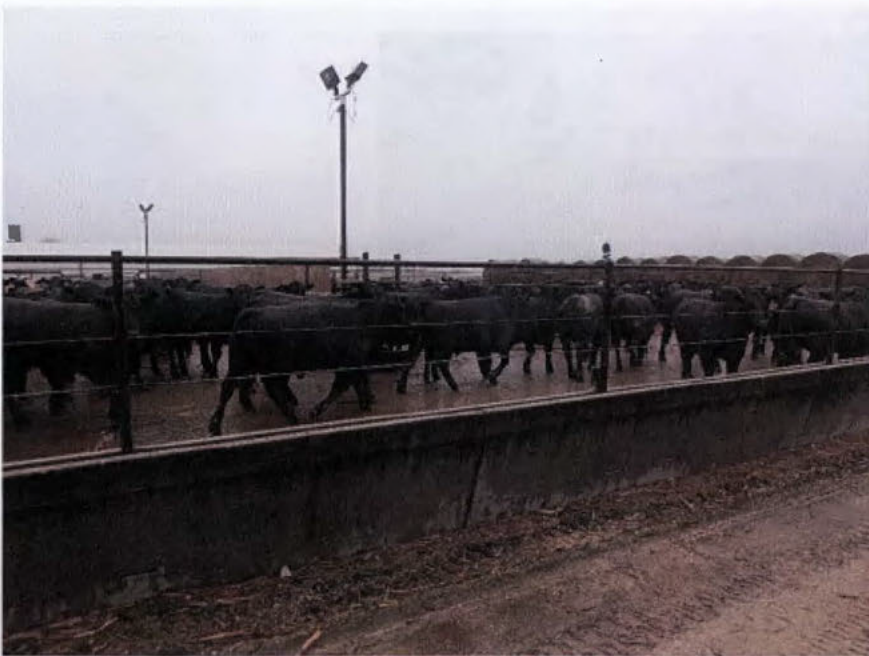
Description: A small amount of feed was on the ground outside the feed trough for the open lots.
